Manhole Inspection Summary

Manhole # S09A1_015MH

Insp Date: **5/14/08 10:18 AM**

Location Address: **1260 Haverhill Rd**

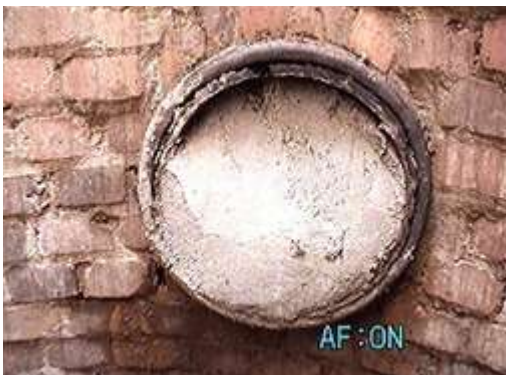
old storm pipe plugged at 8:00

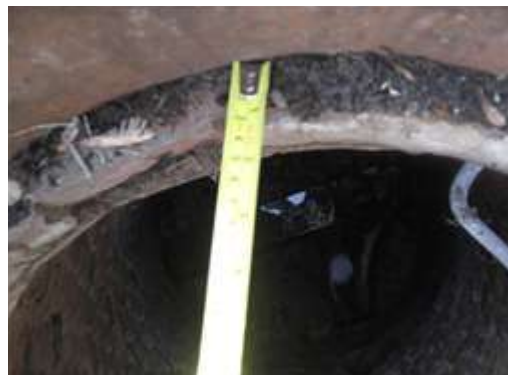
Defect 1

offset 1.25

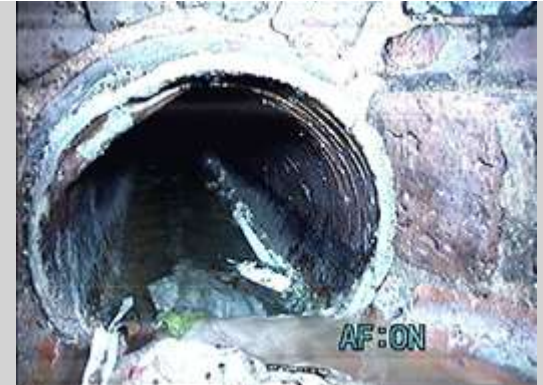
12 O'Clock Outflow

8 in. Circular Gravity Sewer
Pipe Out @ 12 O'Clock

Pipe Height: **8.4** (in.) Rod and Bar (Angled)
Pipe Material: **Clay** ☐ Pipe Lined
Invert Depth: **8.78** (ft.) Flow Characteristics: **Slow**
Deposits: ☒ None ☐ Mud ☐ Gravy ☐ Debris ☐ Grease
Silt Depth: **0** (in.) Deposits Extent:
Infiltration: **None** Pipe Seal Cond: **Sound**

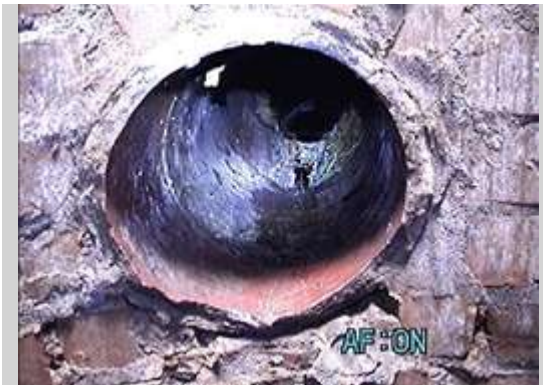
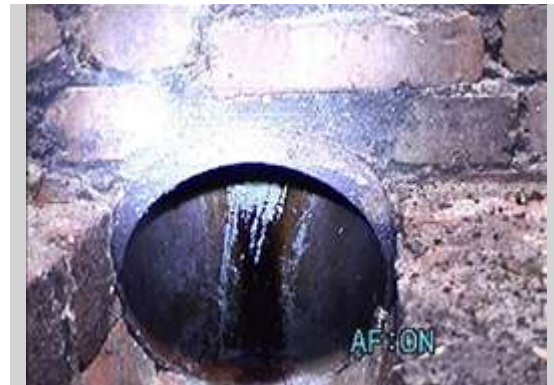
2 O'Clock Inflow

12 in. Circular Gravity Sewer
Pipe In @ 2 O'Clock

Drop In @ 2 O'Clock

Pipe Height: **12** (in.) Rod and Bar (Angled)
Pipe Material: **Clay** ☐ Pipe Lined
Invert Depth: **6.88** (ft.) Flow Characteristics: **Slow**
Deposits: ☒ None ☐ Mud ☐ Gravy ☐ Debris ☐ Grease
Silt Depth: **0** (in.) Deposits Extent:
Infiltration: **None** Pipe Seal Cond: **Sound**

Drop: **Outside** Rod and Bar
Angled: **Yes** Reading: **7.57** (ft.)
Inv Depth: **8.57** (ft.)
Drop Condition: **Open**

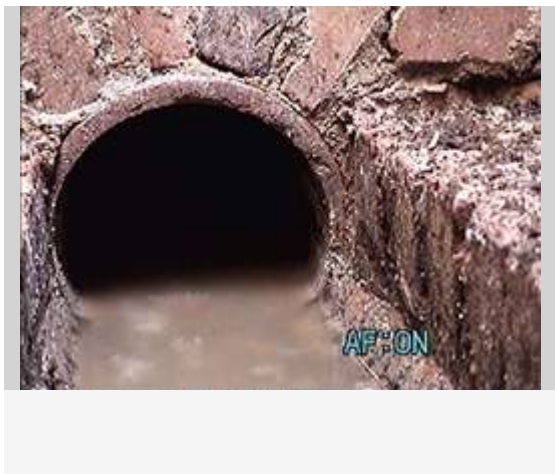
6 O'Clock Inflow

8 in. Circular Gravity Sewer
Pipe In @ 6 O'Clock

Pipe Height: **8.4** (in.) Rod and Bar (Angled)
Pipe Material: **Clay** ☐ Pipe Lined
Invert Depth: **8.68** (ft.) Flow Characteristics: **Slow**
Deposits: ☐ None ☒ **Mud** ☒ **Sludge** ☐ Debris ☐ Grease
Silt Depth: **2.5** (in.) Deposits Extent: **Medium**
Infiltration: **None** Pipe Seal Cond: **Sound**
